### Minerals Inspection Report

Mine Name: Keigley Quarry	Permit Number: M/49/0001	Mine Status: Active
Operator Name: Staker and Parsons Company	Inspection Date: 12/05/2013	Permit Fees: Paid
Inspector(s): April Abate	Inspection Time: 11:00 AM	Bond Amount: \$1,402,000
Attendee(s): Bryson Hinkins, Staker Parsons	Weather: Cold Clear 11 deg	Bond Escalation: 01/01/2017
Inspection Purpose: Inspect the quarry to familiarize myself with the site.		Prior Inspection:

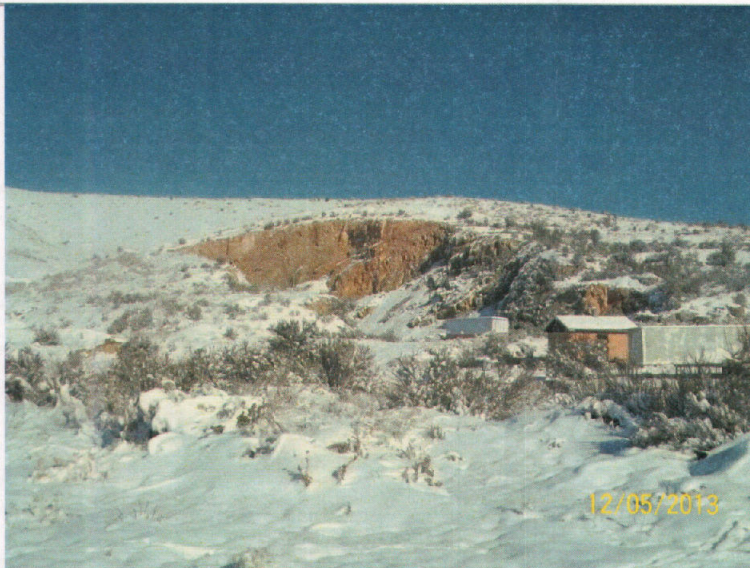
Highwall located on the north side of the site. No mining activity is presently occurring here.

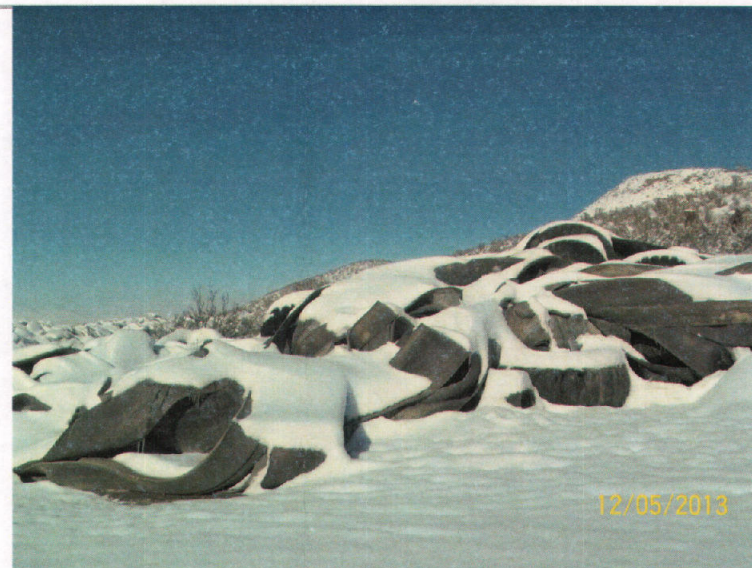
4.	Deleterious Material	<input checked="" type="checkbox"/>	<input type="checkbox"/>
The north portion of the site had a considerable amount of debris consisting of tanker trucks, scrap metal and general construction debris that was left by an individual who had an agreement with Staker Parsons. According to Mr. Hinkins, the company has not had much success with getting the owner to remove the debris from the property. Please note that there is a rule addressing trash, scrap metal and extraneous debris in R647-4-107.1.12 requiring operators to dispose of these types of materials.

A pile of debris was noted on the north side of the property.

The operator should work with the Division to produce an up to date Notice of Intent by the date issued in the NOV of March 4, 2013. The boneyard area on the north side of the property should be cleaned up as soon as possible.

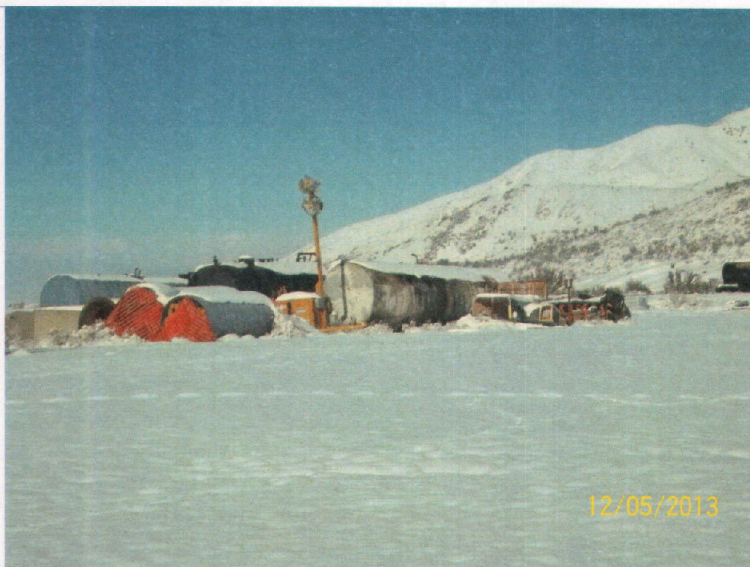
Boneyard area on the north side of the property. This reportedly belongs to an individual who was allowed to store his debris on the property.

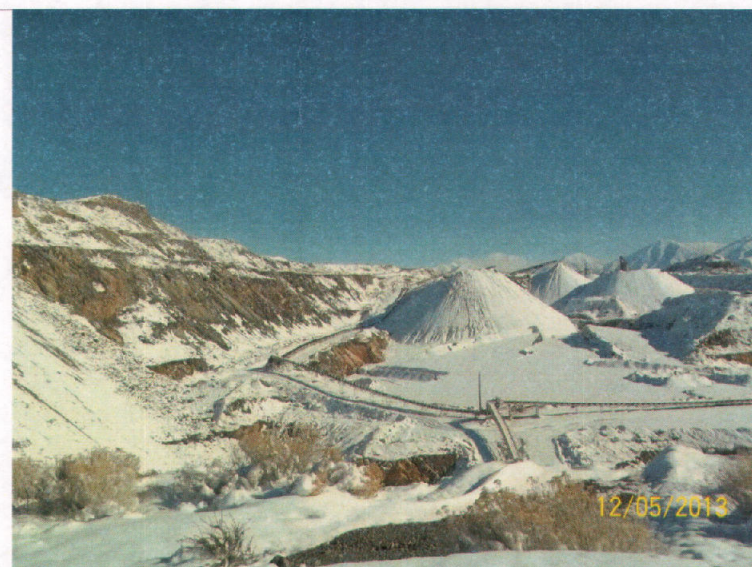
View of the quarry and stockpiles looking east.
